**Subject: Annual Inspection Report
Vaiden Field Airport**

ANNUAL INSPECTION REPORT

OCTOBER 8, 2010

VAIDEN FIELD
MARION, ALABAMA

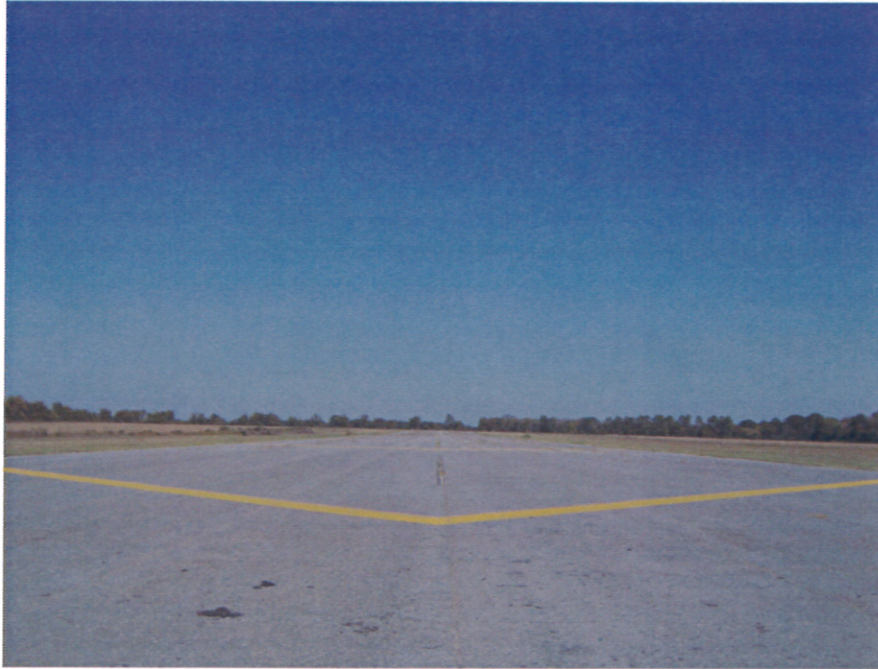
Photo 1

- ➔ The Approach/Departure Paths of runway 16/34 were inspected and found to meet licensing requirements.

Runway 16 approach

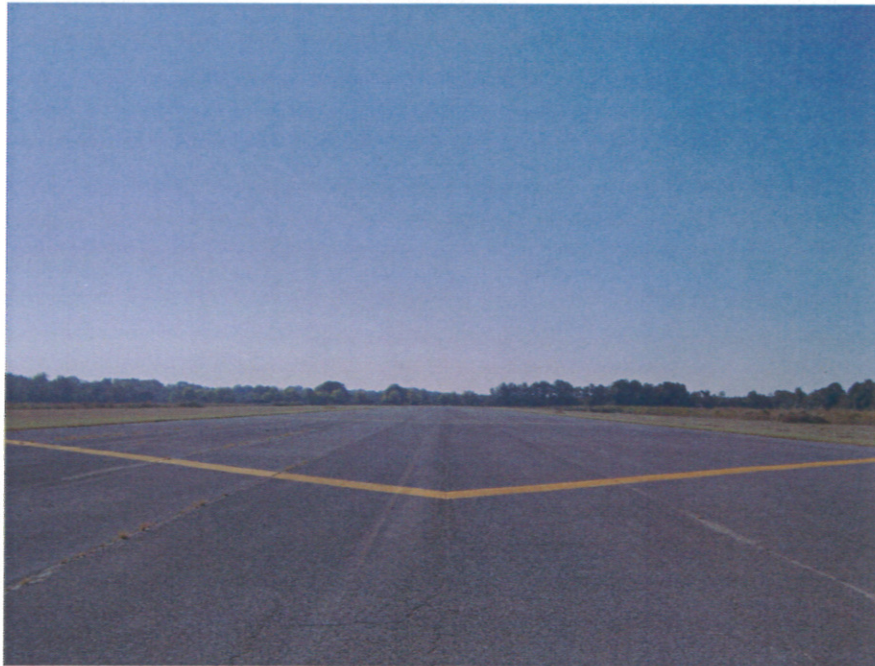
Photo 2

Runway 34 approach

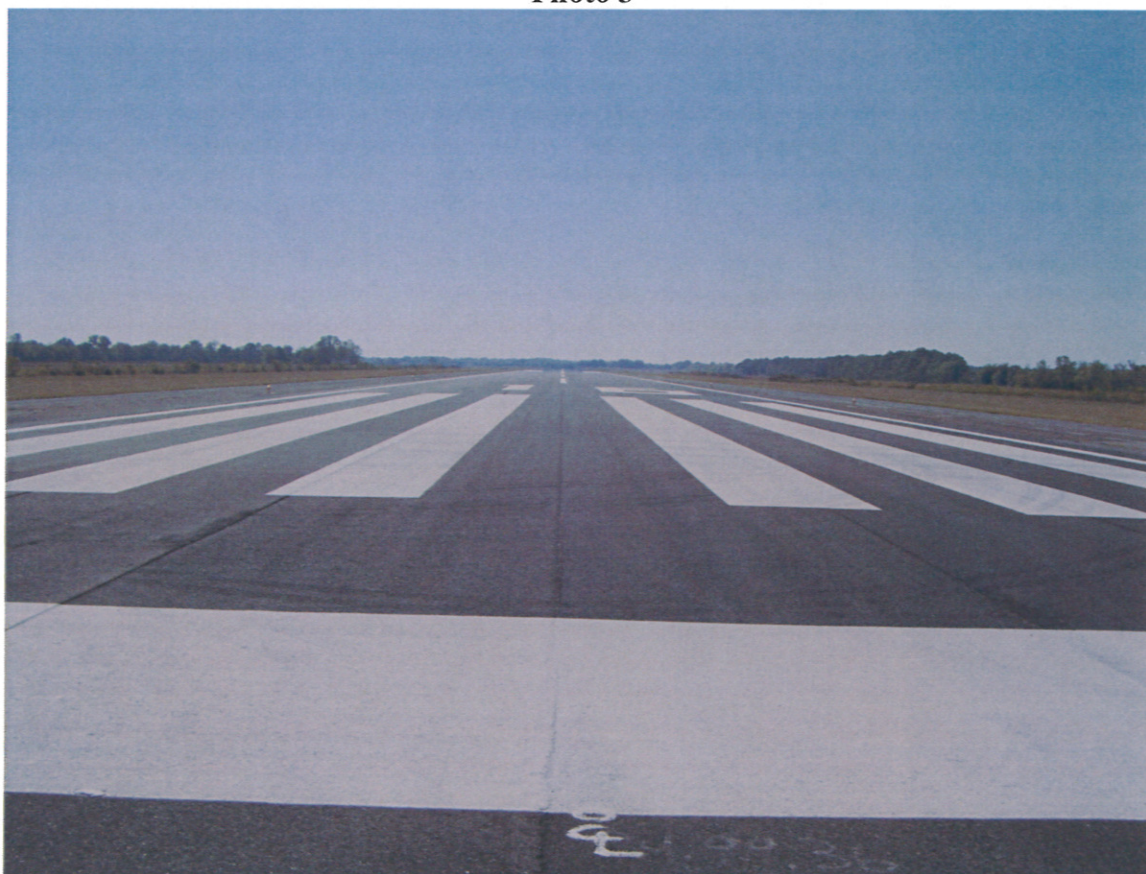
Photo 3

- The runway markings are in GOOD condition.

Runway 16 threshold markings

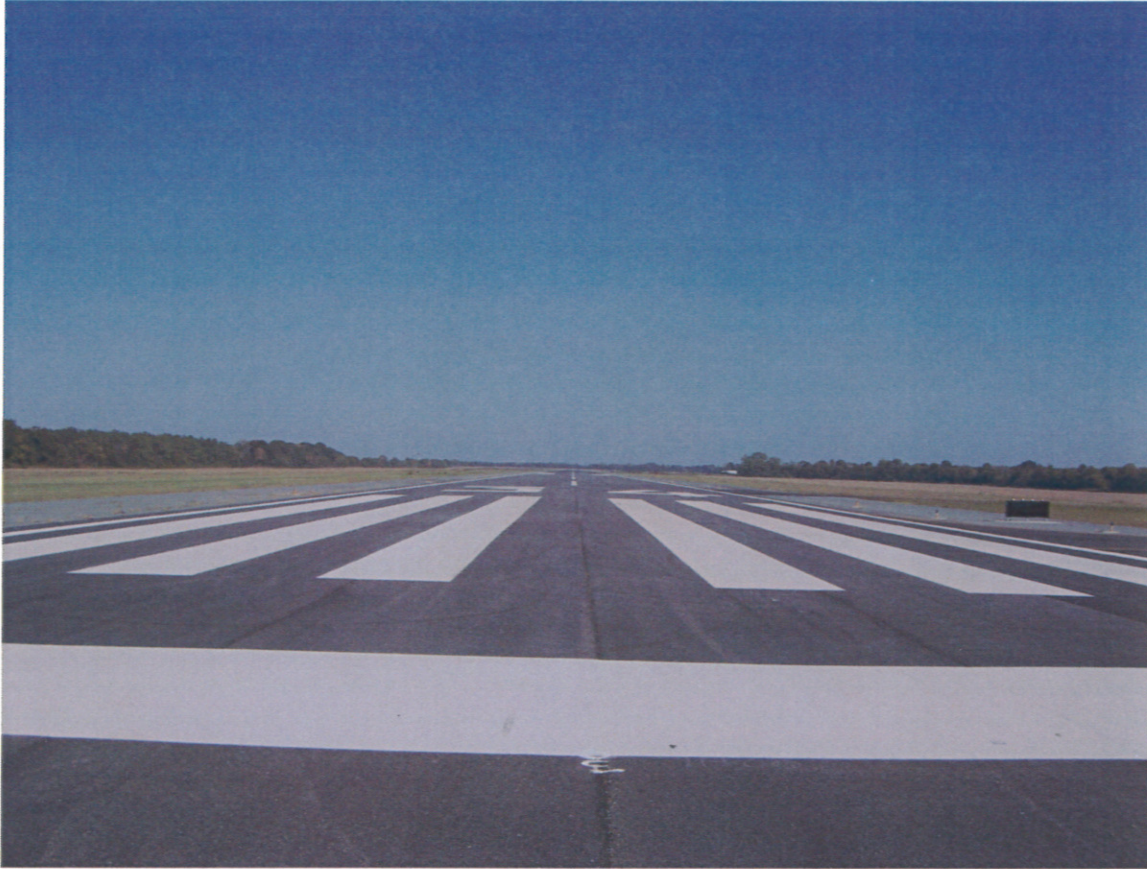
Photo 4

Runway 34 threshold markings

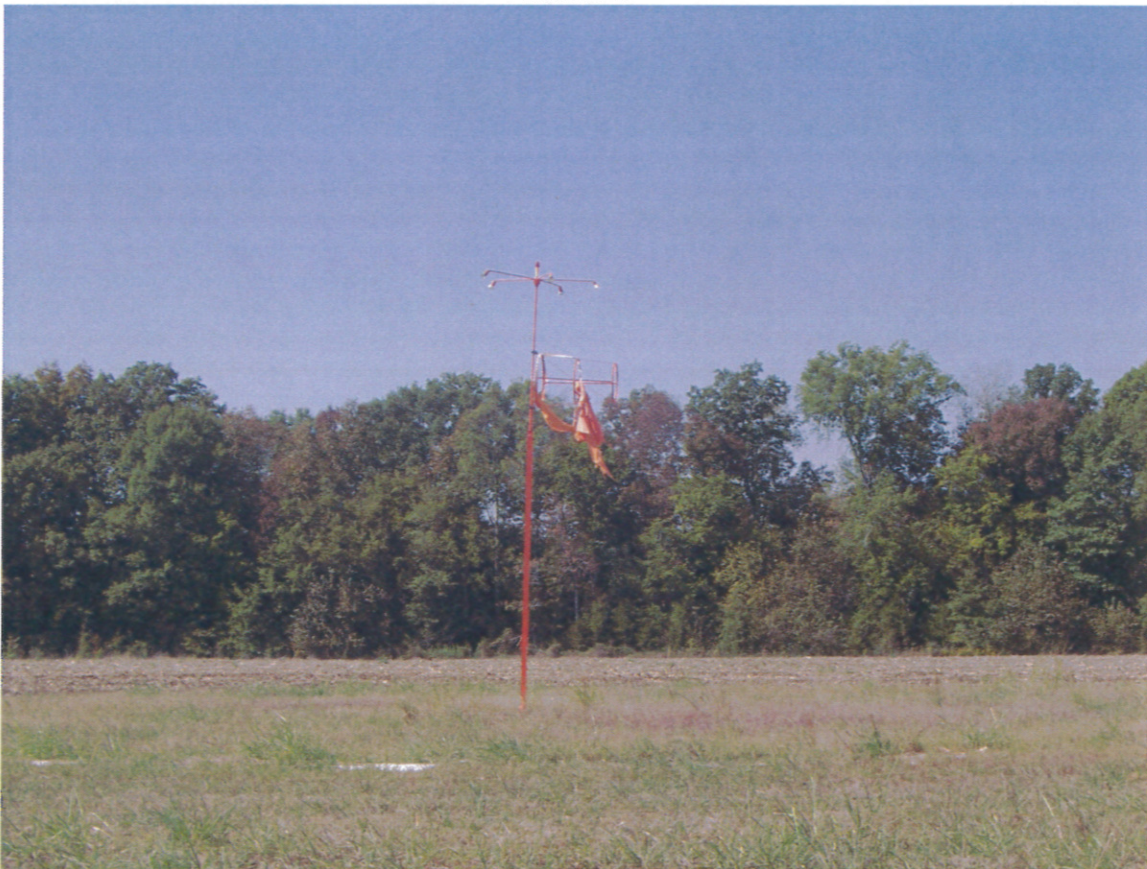
Photo 5

- ➔ The lighted wind direction indicator (windsock) and segmented circle inspection found the windsock to be torn and inoperable.

Windsock torn and inoperable

- ➔ Replace the torn windsock.
- ➔ NOTAM the airport closed to night operations until the windsock is replaced.

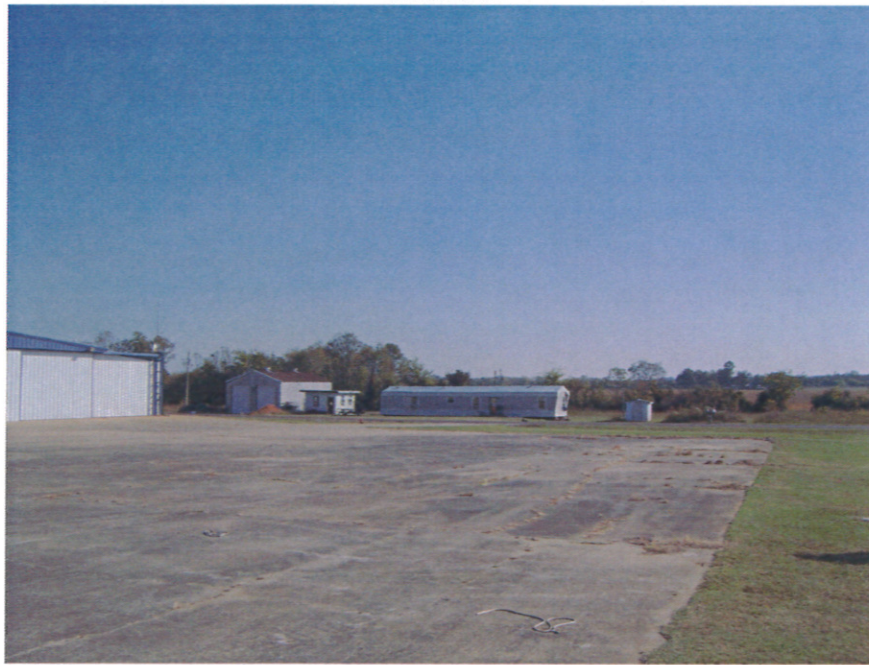
Photo 6

- ➔ The runway, taxiway and a portion of the ramp area were found to be in GOOD condition.
- ➔ The old portion of the ramp area is concrete which has numerous cracks.

Old portion of concrete ramp

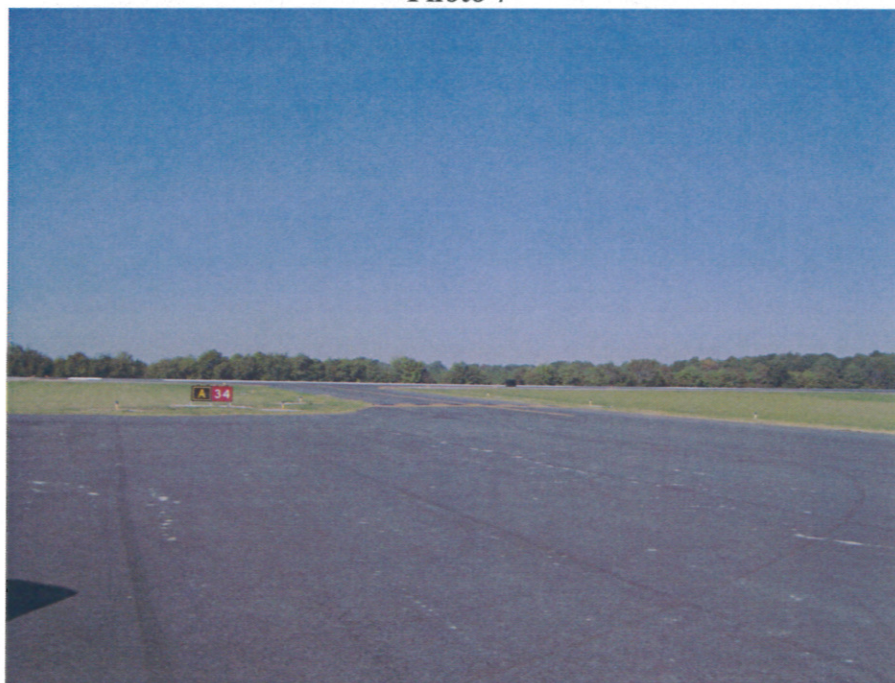
Photo 7

Newly overlayed ramp and taxiway

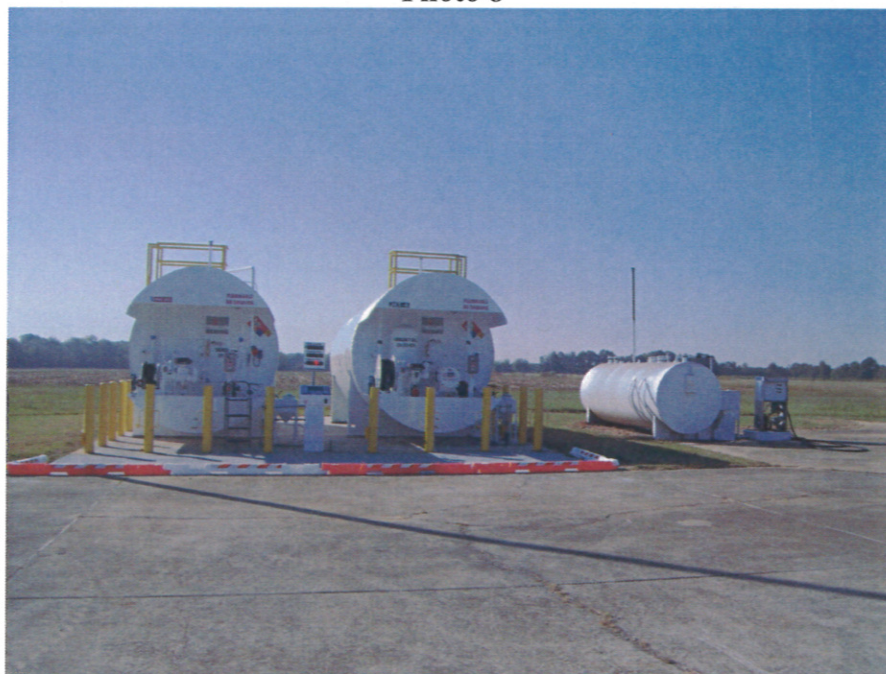
Photo 8

- ➔ The fueling area meets the requirements established by the Alabama Department of Transportation. However, the State of Alabama Department of Agriculture and Industries may have additional requirements for fueling systems that were not considered during this inspection.

Fueling area for Jet A and Avgas
